## Heysham 1 nuclear power station 2014

Osiris had to work closely with an energy provider to safely recover a detached underwater coarse screen.

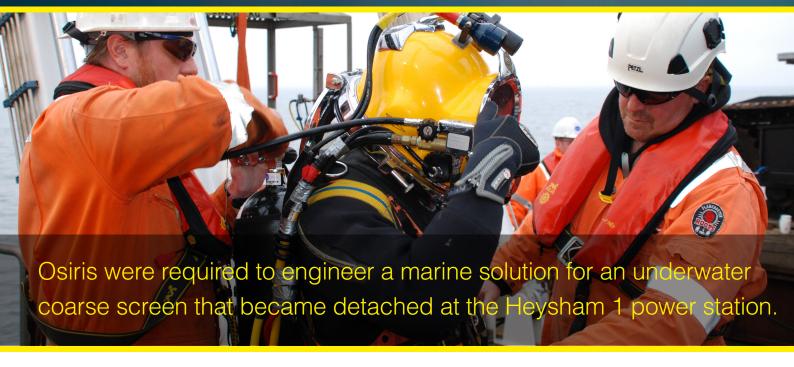
To retrieve the coarse screen Osiris had to assemble a dive team that would operate from a moored vessel in front of the coarse screen. This solution ensured the divers could be closely tendered and allowed the adjacent intakes to remain in service.

The divers fitted air bags to the detached coarse screen, which used the tide to bring the coarse screen back to the surface. Once the air bags were on the surface the vessel mounted crane safely removed the coarse screen from the water.
